Initial Report

RESEARCH INVESTIGATION RI99-033

EVALUATION OF EARLY ENTRY SAWING
OF PCC PAVEMENT

MISSOURI DEPARTMENT OF TRANSPORTATION
RESEARCH, DEVELOPMENT AND TECHNOLOGY

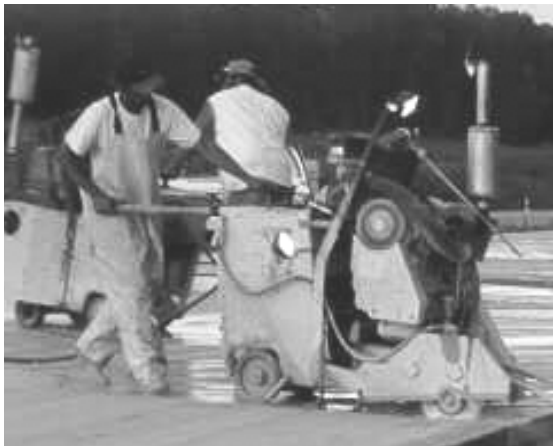
Conventional Saw

The early entry sawing that was demonstrated on September 14, 1999 was done with a Soff-Cut 20hp model. The early entry sawing was a dry operation that eliminated the need for a water source to cool the saw blades, as is needed with the conventional saws. The Soff-Cut saw was equipped with a blade enclosure that prevented dust from becoming airborne. The dust from the joint was left neatly alongside and in the joint. Below are pictures of both the early entry saw and the conventional saw during operation.

The quality of both types of saw cuts was good, with very little or no raveling observed after sawing. It was noted, however, the side faces of the conventionally cut joints were very smooth and had a polished appearance. The side faces of the early entry sawed joint had a rougher texture. It is possible that the rougher surface may improve the bond with the joint sealer material, although this has not been proven.
